**FAKULTA
STROJNÍ
ČVUT V PRAZE**

Test report no. 12133_05_2026_LK

Analysis of bolt welds

A test sample containing 5 welded joints of bolts with a diameter of M12 made of material Wr.N. 1.4541, welded on a plate made of material S355, was submitted.

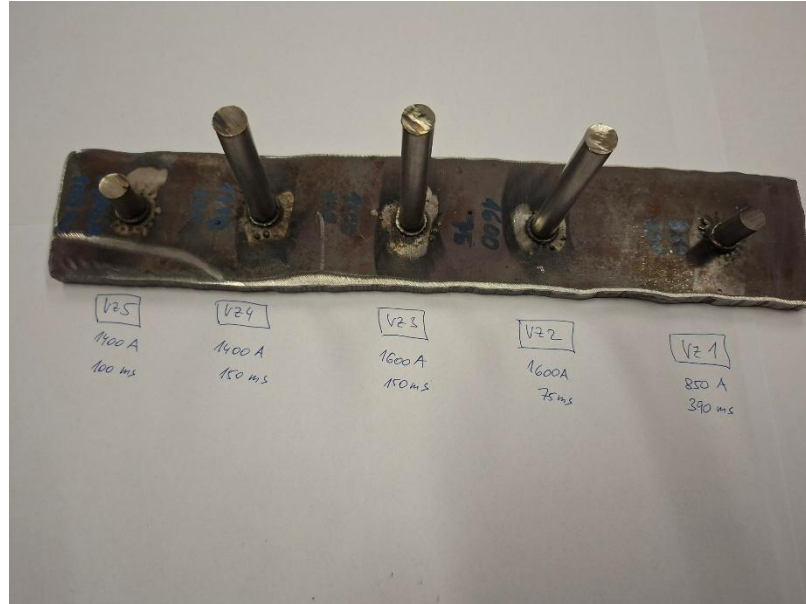
Fig. No. 1. – Supplied test sample with welded joints

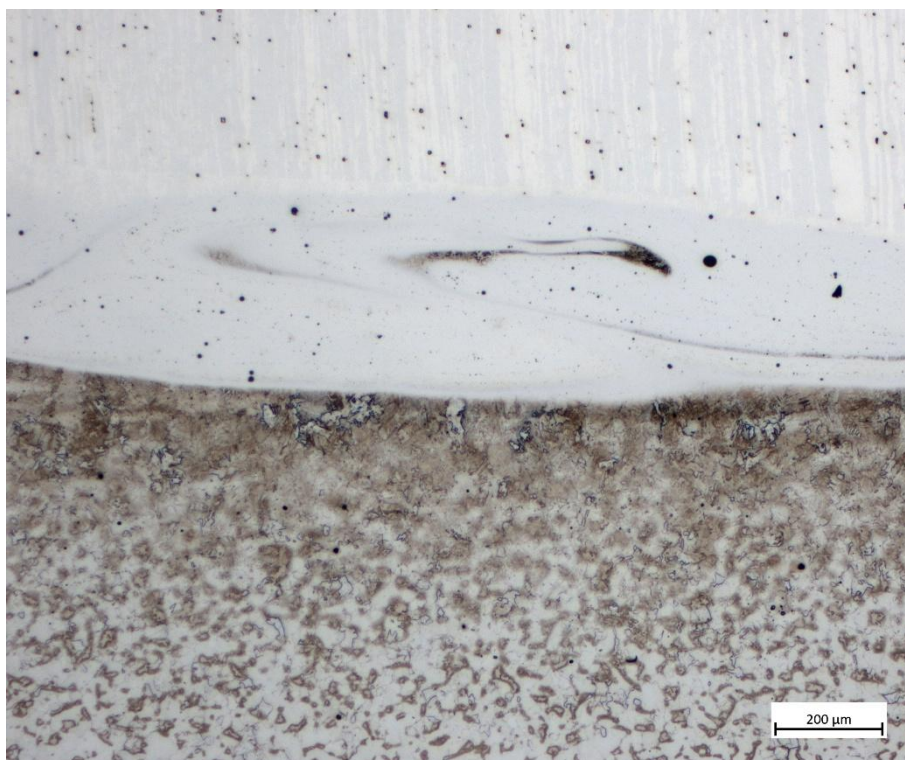
*Fig. 7 – Detail of the microstructure of the welded joint No. 1 – magnification 50x
(transition between the bolt - upper part of the picture and the base plate - lower part of the picture)*

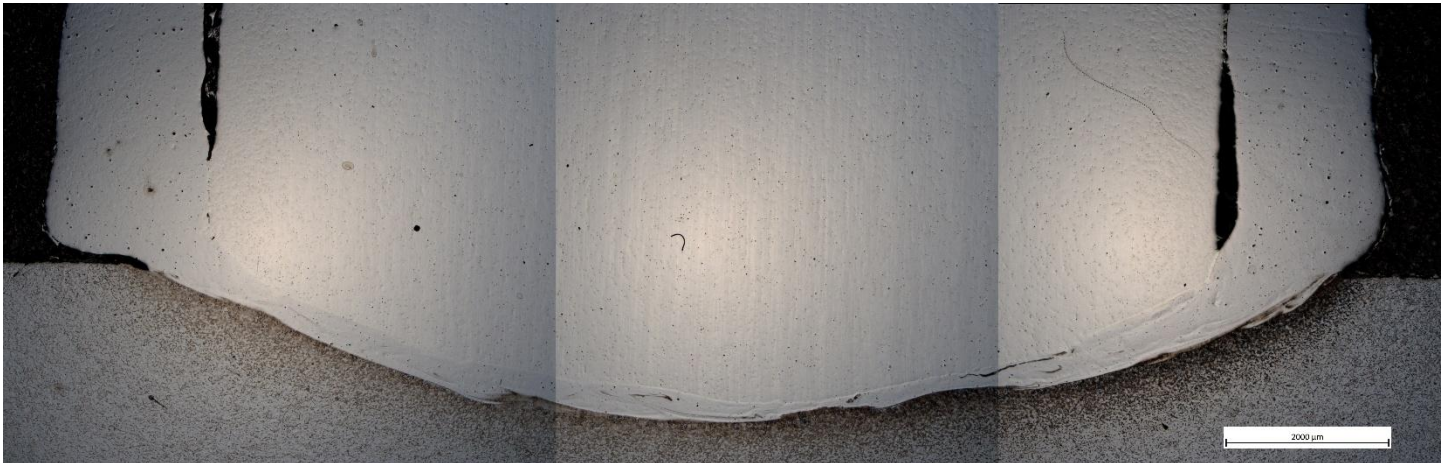
Fig. 8 – Microstructure of the entire weld joint No. 1 – magnification 25x

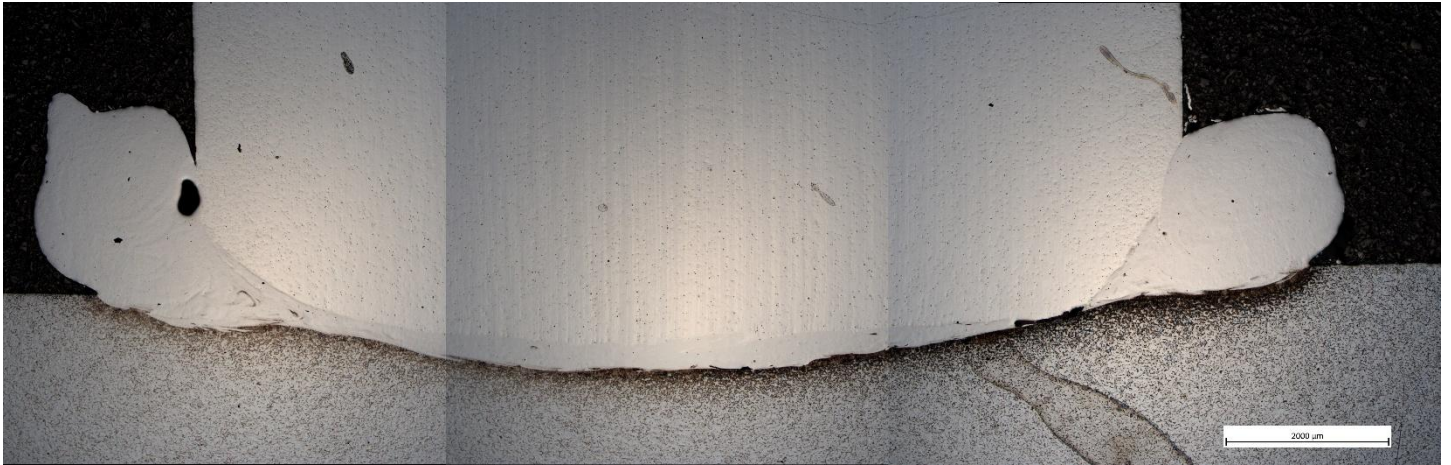
Fig. 10 – Microstructure of the entire weld joint No. 2 – magnification 25x

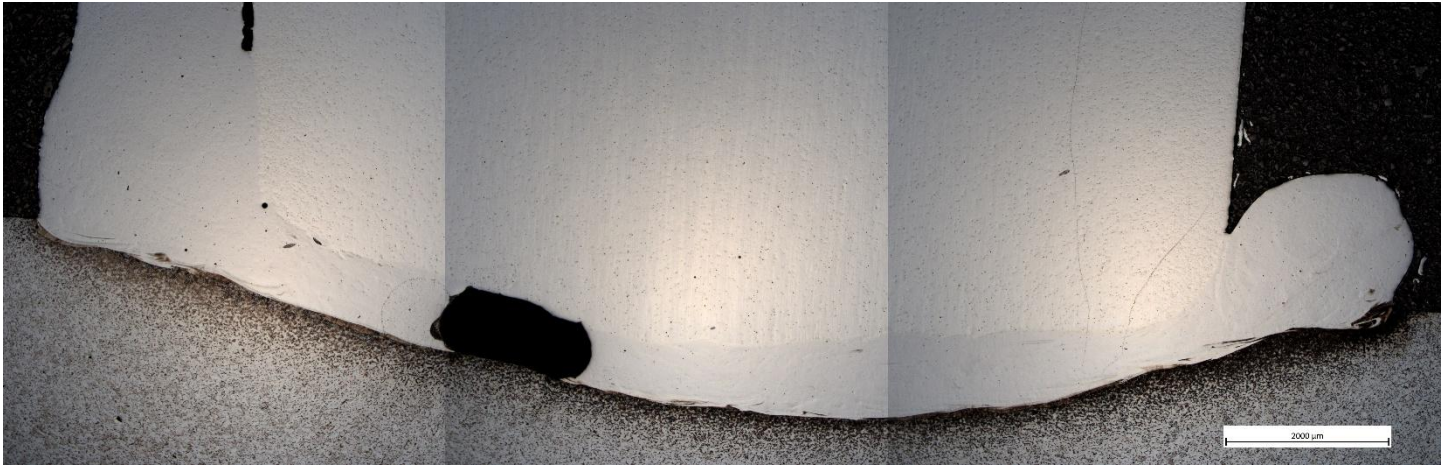
Fig. 14 – Microstructure of the entire weld joint No. 4 – magnification 25x

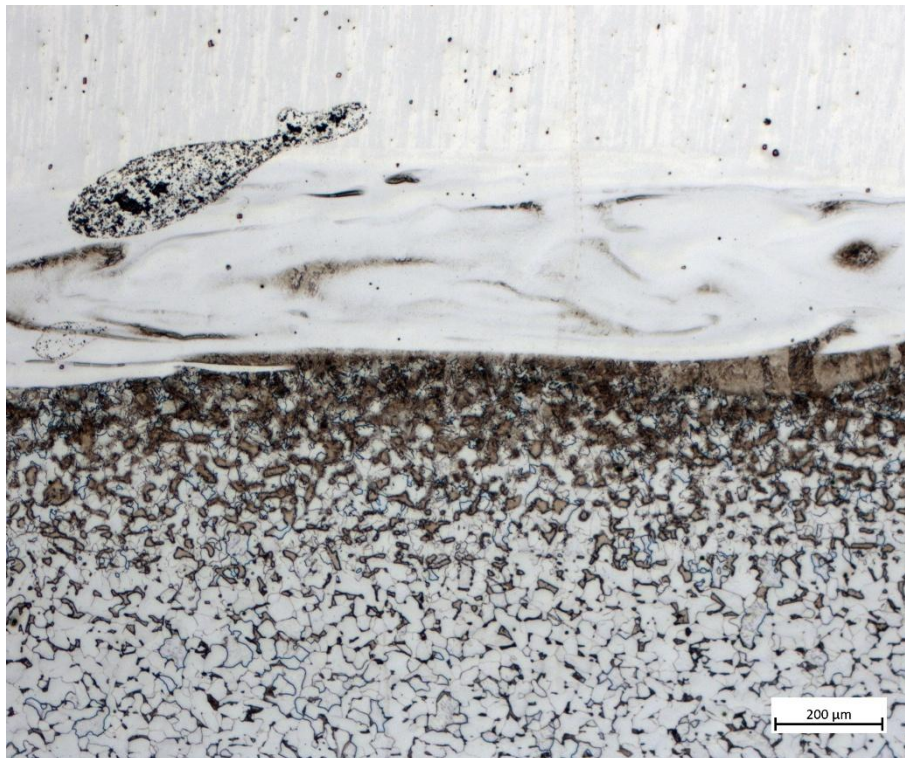
Fig. 15 – Detail of the microstructure of the welded joint No. 5 – magnification 50x
(transition between the bolt - upper part of the picture and the base plate - lower part of the picture)

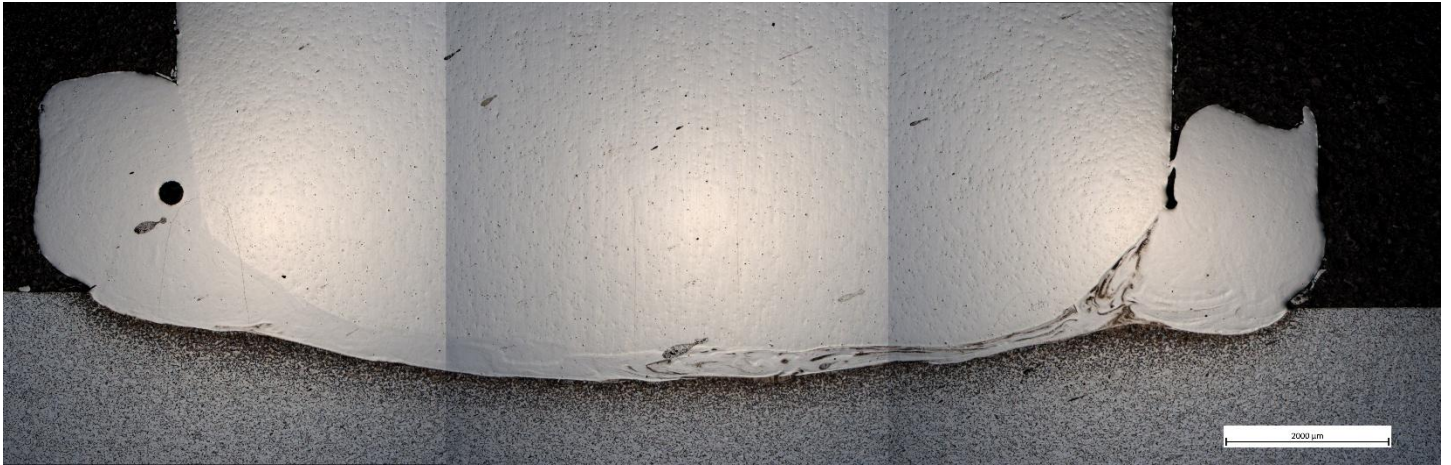
Fig. 16 – Microstructure of the entire weld joint No. 5 – magnification 25x

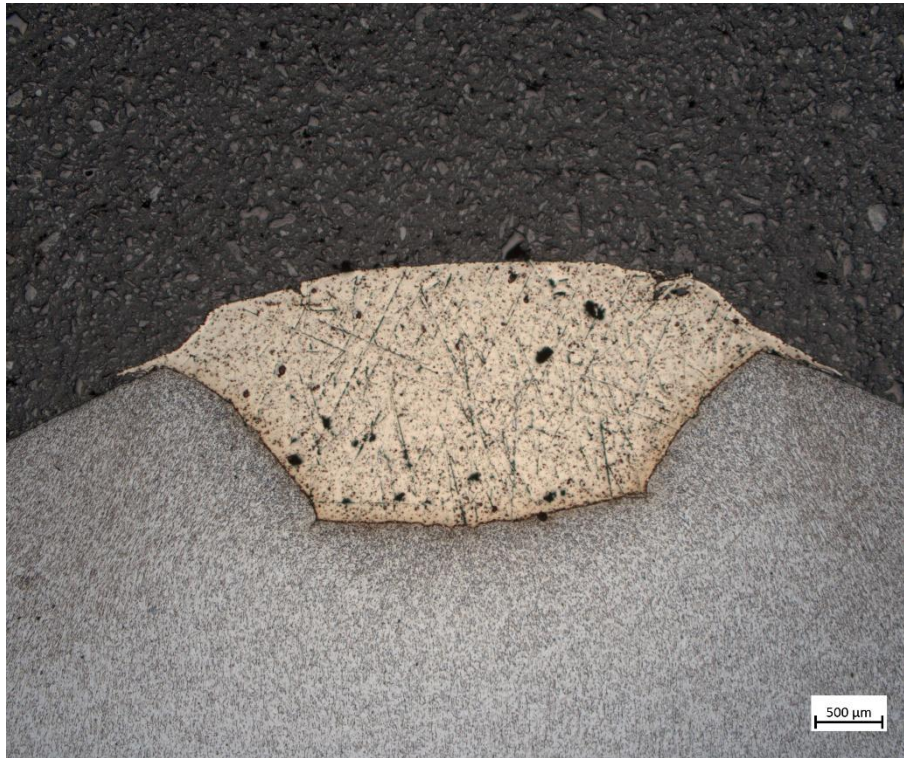
Fig. 17 – Microstructure of the end part of the bolt (before welding) – magnification 25x

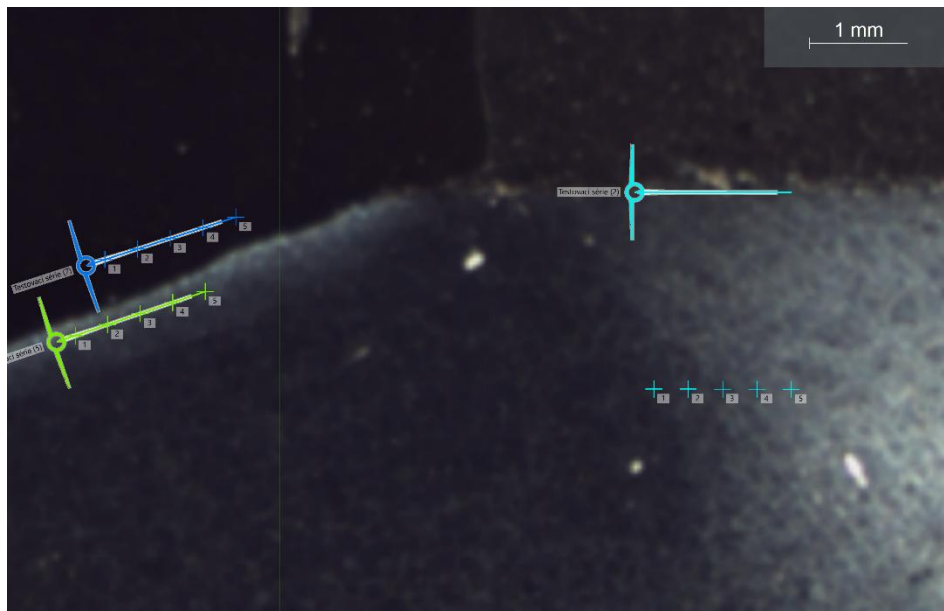
Fig. 20 – Display of the number and order of injections in a test series TS2, TS5 and TS7

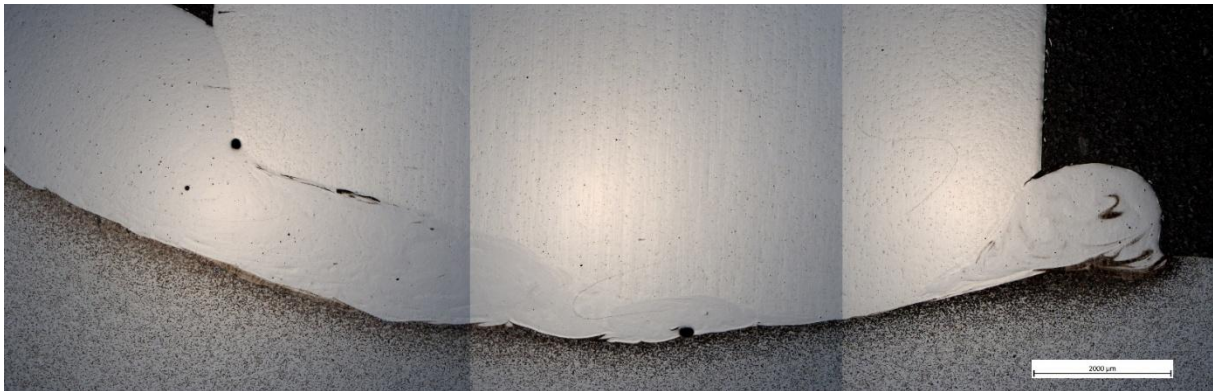
Fig. No. 44A (auxiliary image) – join – Stud 3

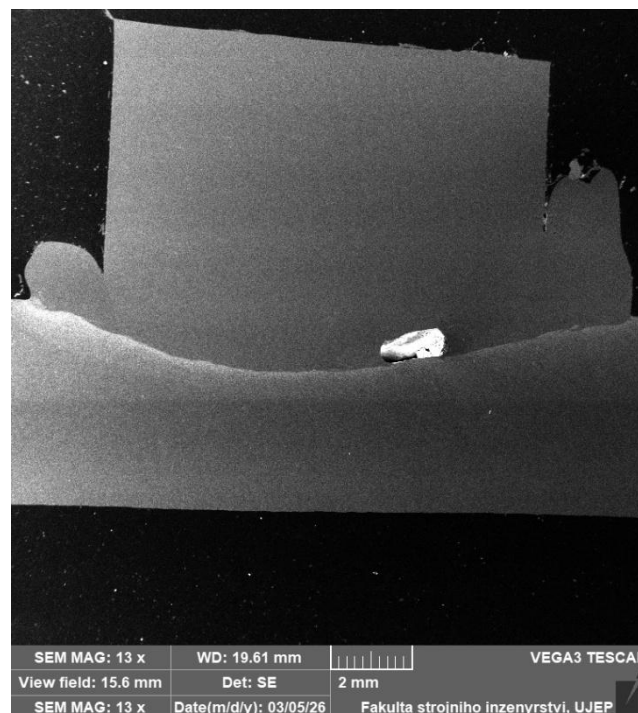
Fig. No. 53 – Joint – Stud 4 – mirror image of the image from the metallographic microscope. This stud also has an irregular protrusion, and a defect – a pore – is also discernible, which upon closer examination has the character of a dropped inclusion (Fig. No. 54).

Again, the Stud is not welded perpendicularly to the S355 steel, which was also reflected in the unevenness of the weld bead. There is a significant defect in the weld area, which was created in connection with a large oxide

inclusion that fell out. Its presence was confirmed by EDS analysis and also by morphology. Another globular inclusion of an oxide nature was analyzed in this joint, which, however, was outside the clearly defined area of the weld metal. Its presence documents that a long time and a relatively large heat input caused the melting of a larger part of the S355 steel, which did not mix with the Stud steel and subsequently solidified even with the inclusion present. This is an area of approximately 70 μm in size. This area has a bainitic and sometimes martensitic structure with an increased concentration of chromium, however, its concentration corresponds to the diffusion process, not the process of mixing the melt from the melted Stud. Only at the Stud 4 joint were these small but continuous carbides detected along the austenitic grain boundaries at the Stud location, i.e. on the Wr.N. 1.4541 steel side. Unfortunately, their size does not allow for their separate EDS analysis, but as in the previous case, they are likely to be cementite-based carbides. However, their danger may be not only intergranular corrosion, but also embrittlement of the otherwise tough austenite.

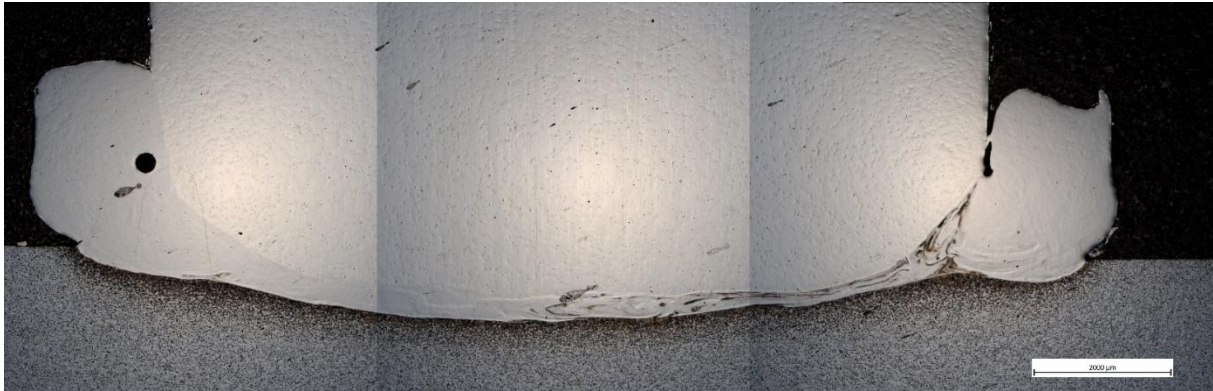
Fig. No. 62 – Joint – Stud 5 – overall scanning electron microscope image missing

The stud is welded relatively straight, which was positively reflected in the size of the spatter. The mixing of the weld metal melt had, as in Stud 1, areas in which the S355 material was in the middle of the weld metal consisting mainly of Stud, i.e. stainless steel with a reduced concentration of Cr and Ni. at the boundary of the structure – the structure is formed by lower bainite, which passes into upper bainite. No pronounced carbide lines were detected at the interface as in Stud 3. The heterogeneity of the weld metal may represent an increased corrosion risk. The cloudy structure is also not favorable in terms of joint strength, because it can initiate brittle damage.
